# Regional Road Inspection Tour

November 2014

## Alternative 'Inland' Highway - Brisbane to Cairns

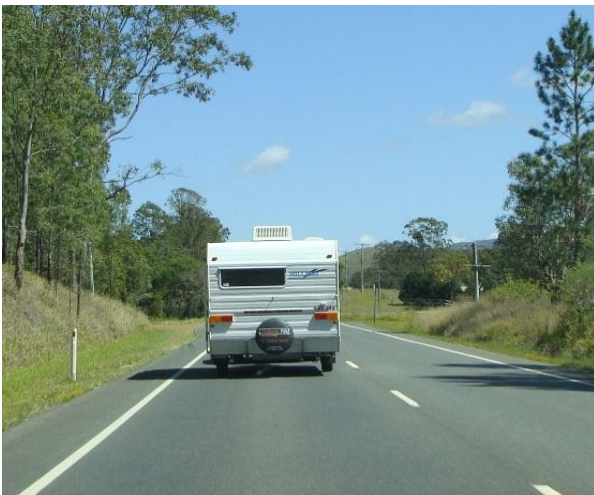
There is a distinct lack of overtaking lanes along the higher volumes sections (east of Kilcoy) which tends to increase driver frustration and can lead to unsafe overtaking manoeuvres.

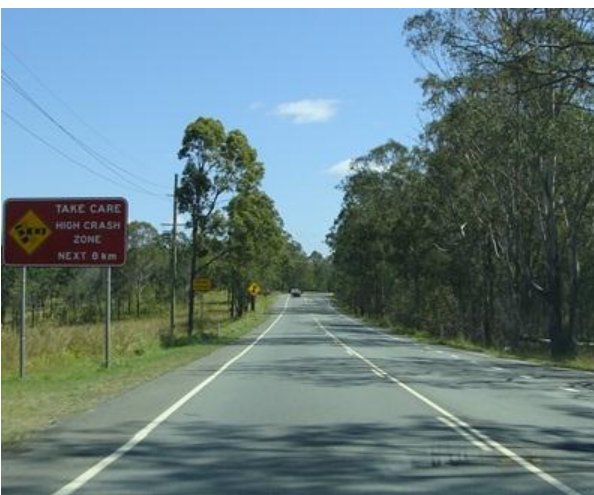
Audio Tactile Line Marking (ATLM) is used in sections and roadside hazards (trees) are positioned too close to the edge line.

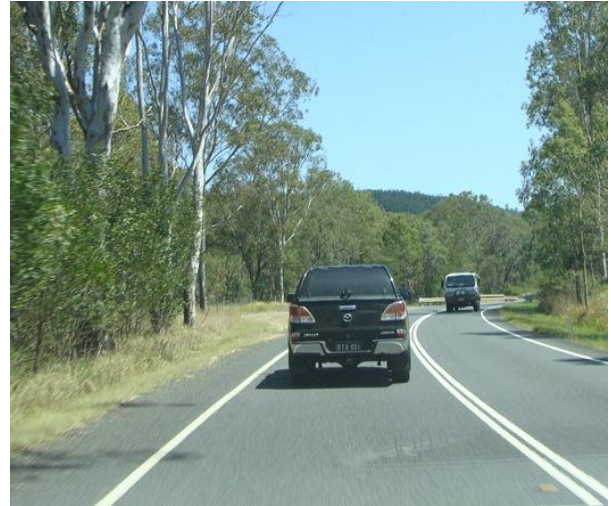
The road is hilly and winding along much of its length to Kingaroy. The road width varies between narrow (<8m) and adequate (8m or more) through to Nanango, with some bumpy sections contributing to poor ride quality.

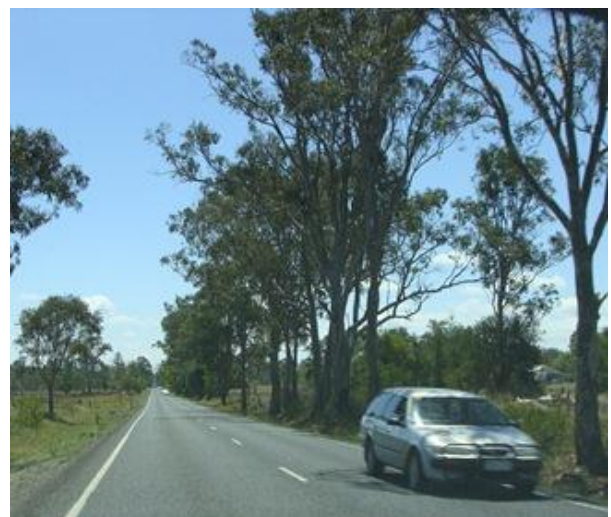
ATLM is used in sections but could be extended to all edge and centre lines, especially on approach to crests, curves and bridge approaches.

The D'Aguilar Highway is mostly tree-lined, travelling through lush forest areas and undulating terrain. There are many roadside hazards (trees) with limited use of safety barriers.

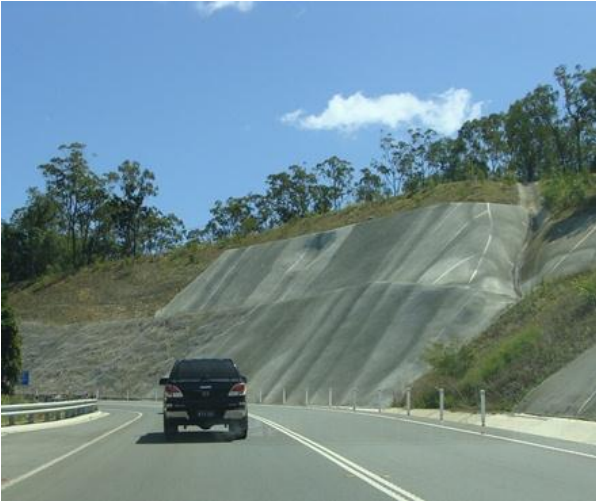
The Blackbutt Range has been upgraded after land slips caused significant damage due to heavy rains.

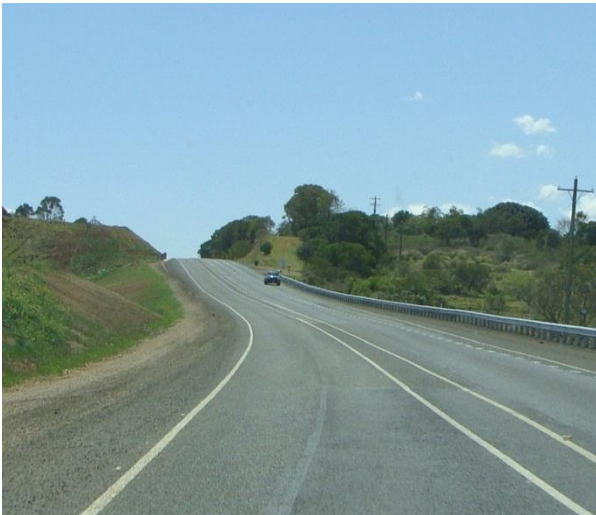
A new overtaking lane with wide centre line treatment is a welcome addition about 10km south of Nanango, although overtaking lanes and opportunities are minimal between Kilcoy and Nanango.

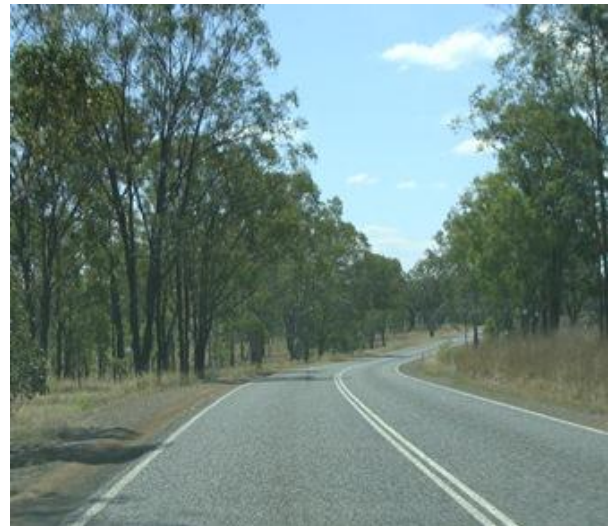
The road between Nanango and Goomeri continues as winding and hilly with seal width generally 8m or more - apart from a 10km narrow section (6 – 7m) approximately 25km north of Nanango. Heavy vehicles drop the left wheels onto the unsealed surface due to limited seal width when passing. Trees close to the road are a safety issue.

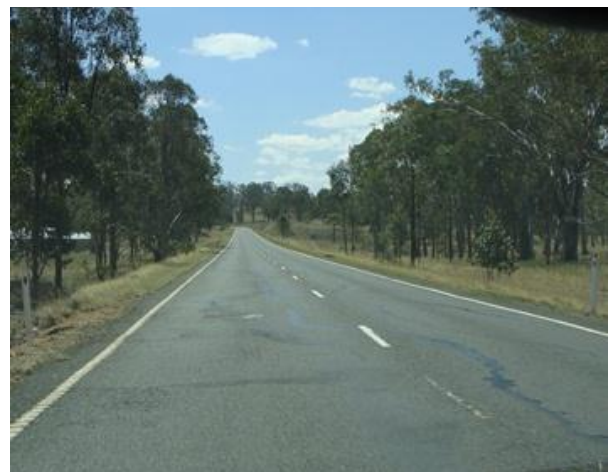
ATLM is present in sections along with some crack sealing to prolong the life of the pavement and avoid surface failures. In general the surface condition is good.

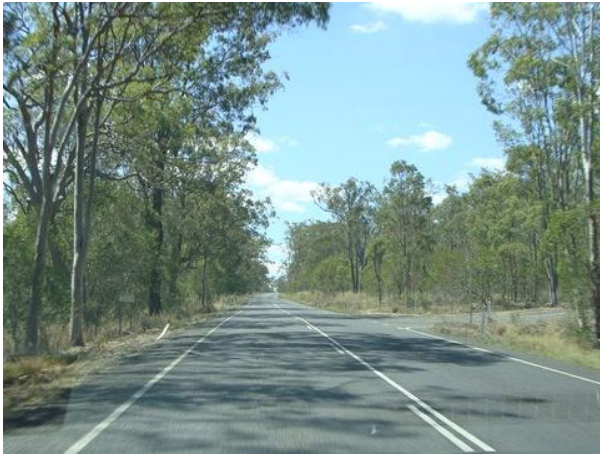
Safety at some intersections could be improved by widening the shoulders or providing a dedicated right turn lane, even where side road volumes are low.

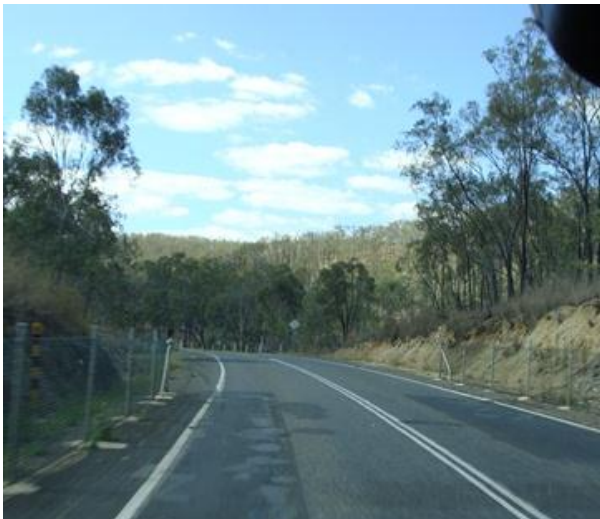
There are newly upgraded sections, including through cuttings, but also sections that still require improvements to the condition and quality of the road surface.

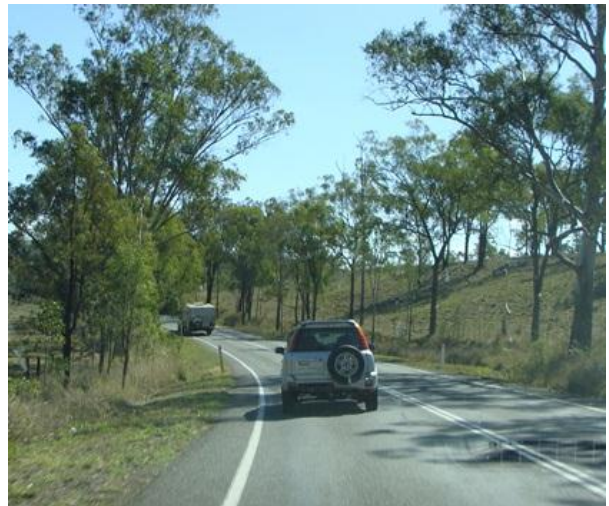
Safety barrier could be used in the sections with poor roadsides including steep embankments and tree hazards.

Some cuttings were prone to landslips. Distance to roadside hazards (trees) also varies, as does the presence of ATLM.

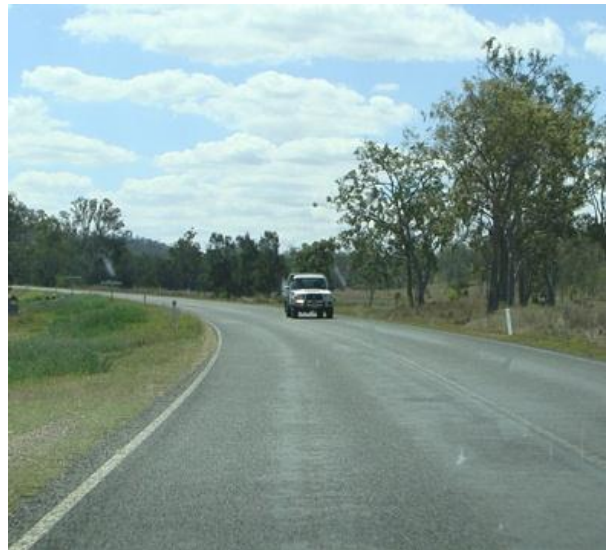
Some road markings (centre-line) have faded and require remarking approximately 5km north of Tansey.

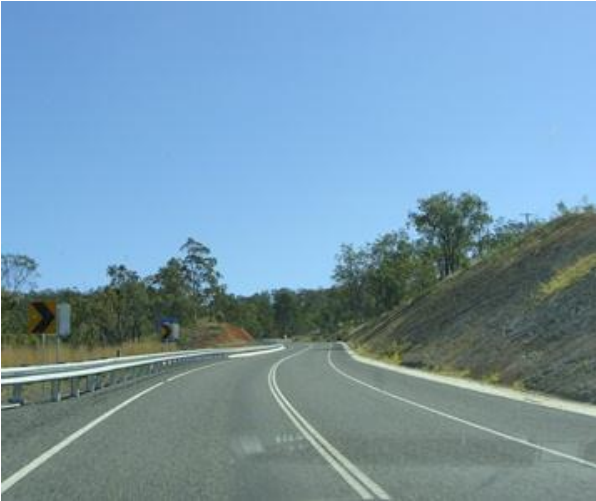
The Binjour Range section has received an upgrade with safety barriers and drainage improvements, but still requires an overtaking lane, or alternative (e.g., climbing lane / slow turnout) to reduce frustration at being behind a slow moving vehicle.

In general, overtaking opportunities could be improved between Nanango and Eidsvold due to the poor horizontal and vertical alignment.

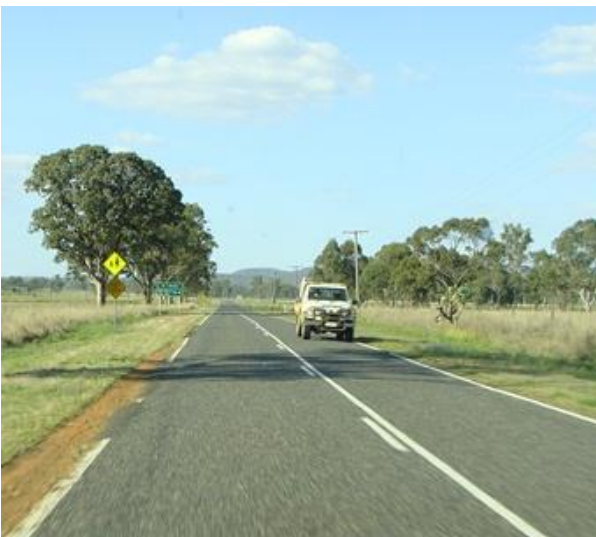
About 35km north of Eidsvold the seal width drops below 7m with larger vehicles having to drop wheels off the sealed surface to pass safely.

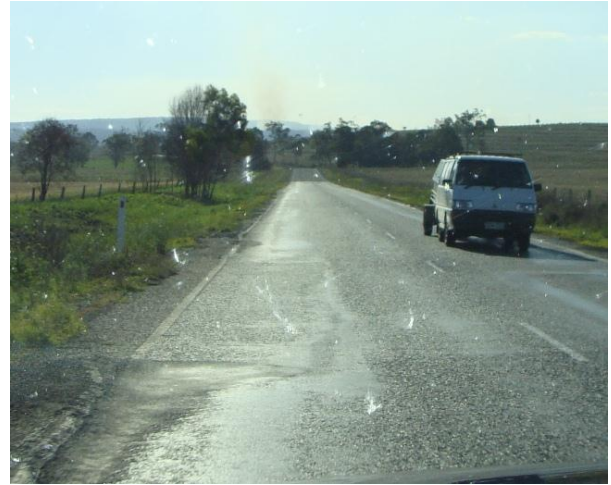
Some upgrades and repairs have been undertaken, e.g., 60km from Biloela. However the ride quality is generally poor, bumpy and undulating with sections prone to surface failures and cracking.

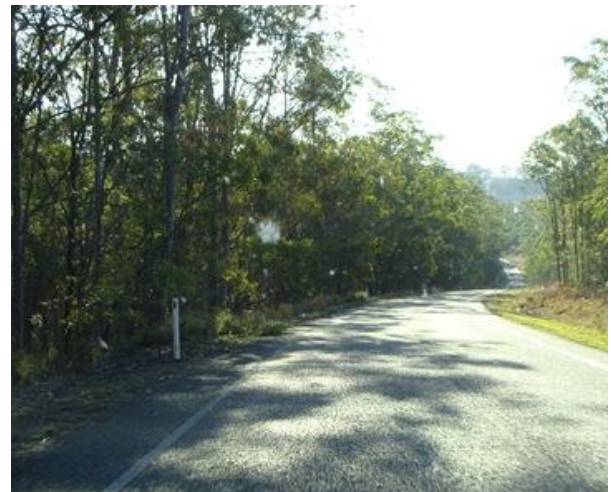
Roadside hazards such as trees are close to the carriageway and pose a serious safety risk. The lines require remarking approximately 20km north of Monto and ATLM would be beneficial over the entire section between Eidsvold and Biloela.

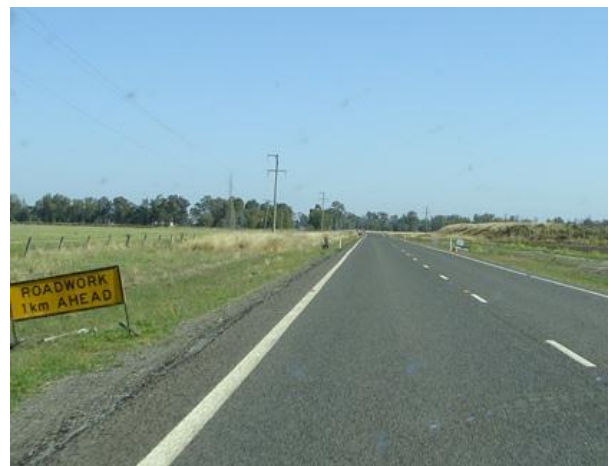
From Biloela to Dululu (~75km) there are recently widened (8m+) and upgraded sections with some road works taking place at the time of inspection (see image below, ref. between Biloela and Jambin).

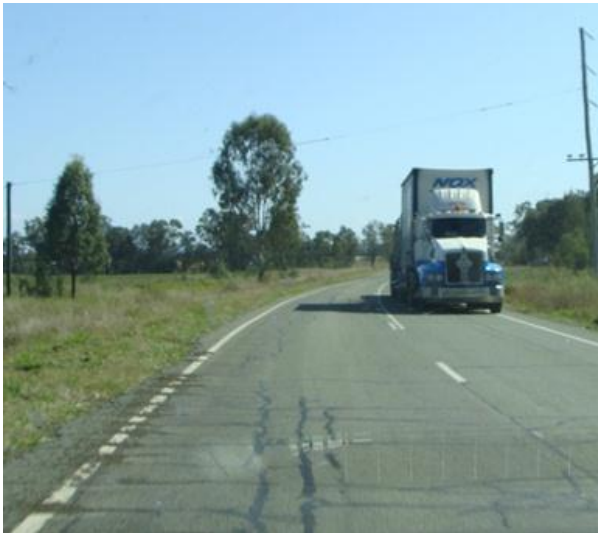
Sections are still prone to surface failures and there has been extensive crack sealing works to extend the life of the pavement and make it more resilient to damage.

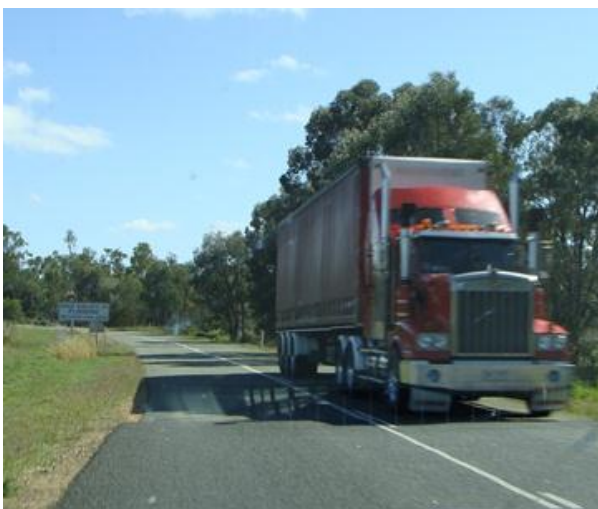
There are many floodways and creek crossings which may require flood immunity improvements to ensure the frequency and duration of road closures due to flooding is minimised.

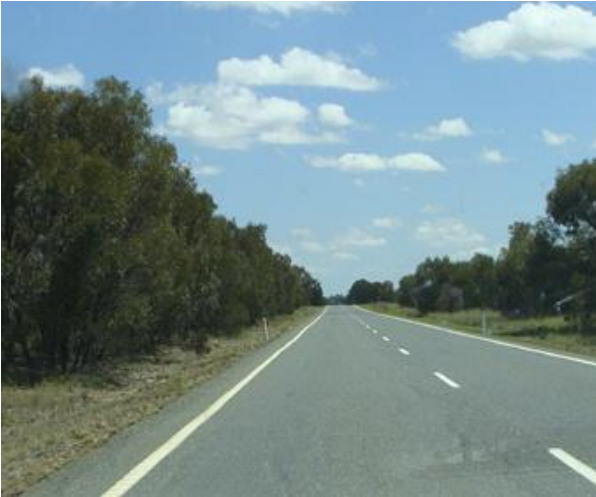
These trees pose a hazard to errant vehicles, especially as they become more established in the future.

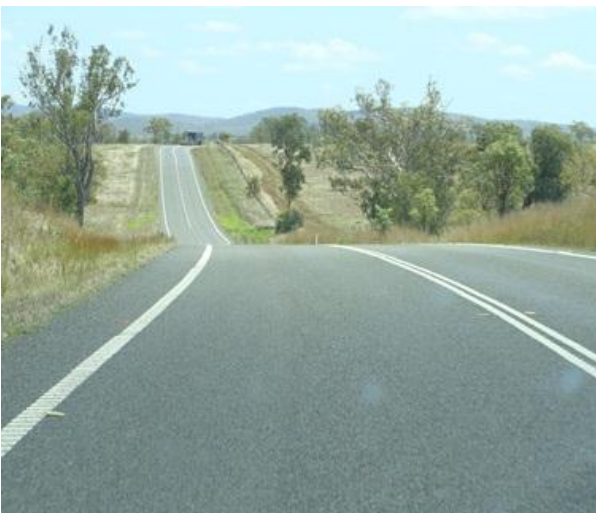
The road surface quality and ride quality is generally good over most of this link apart from the 10km section north of Dululu which was bumpy and was prone to surface cracking. ATLM was used in sections on the edge and centre line, including at curves and crests.

Improvements should focus on clearing roadside hazards and improving ride quality over the first 10km north of Dululu.

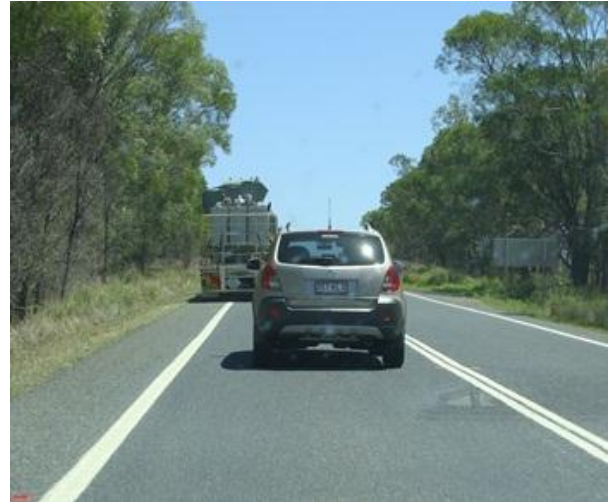
Overtaking can be an issue due to the higher traffic volumes and presence of trucks and oversize loads.

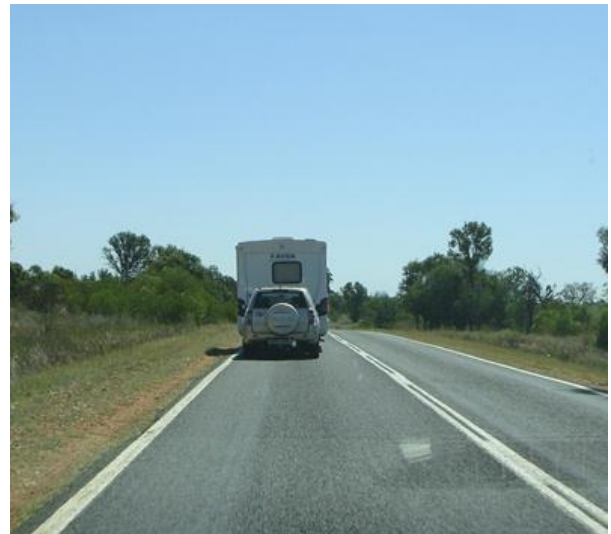
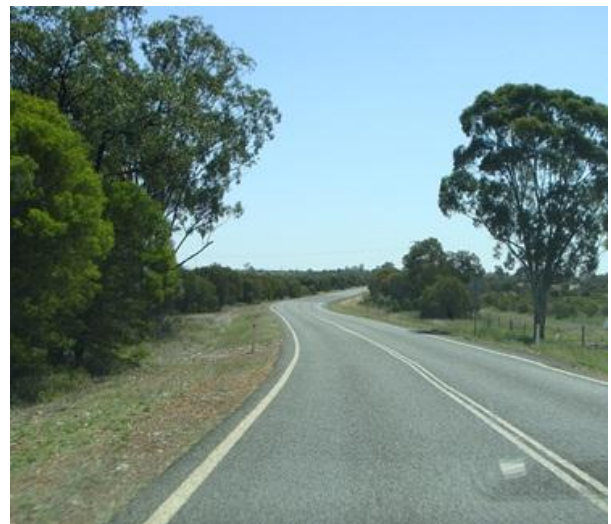
The Emerald – Rockhampton section of Capricorn Highway is generally good, apart from the Comet to Emerald section where the road narrows and road condition suffers.

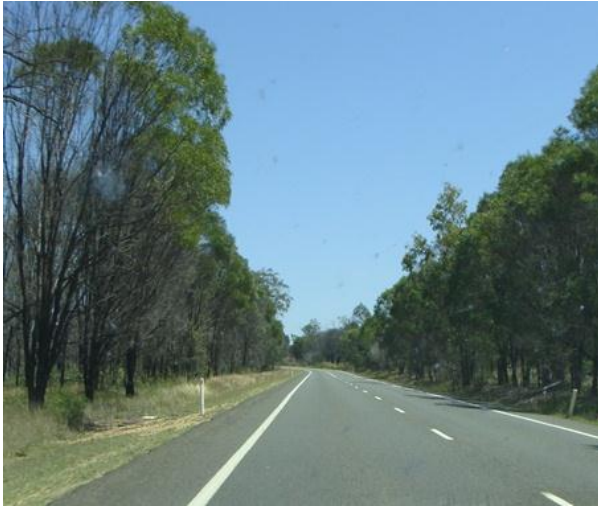
There are some roadside hazards (trees mainly) that could be removed, e.g., west of Duaringa, east of Bluff.

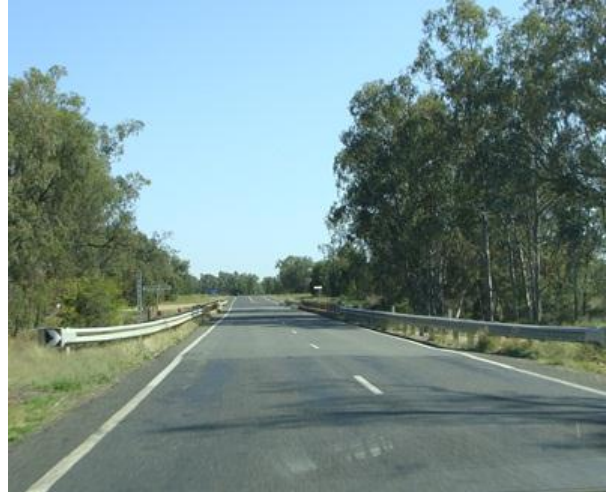
In general the road width from Emerald to Capella is 8m or more and the road condition (and roadsides) are good, with only some sections that are bumpy. Some surface cracking is present.

Floodways and creek crossings are common.

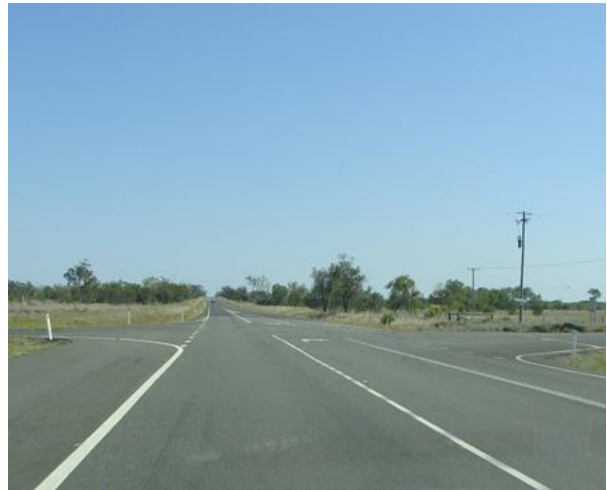
A Channelised Right Turn (CHR) intersection treatment was located approximately 20km south of Capella and is a positive safety improvement, as is ATLM which is present over much of this length.

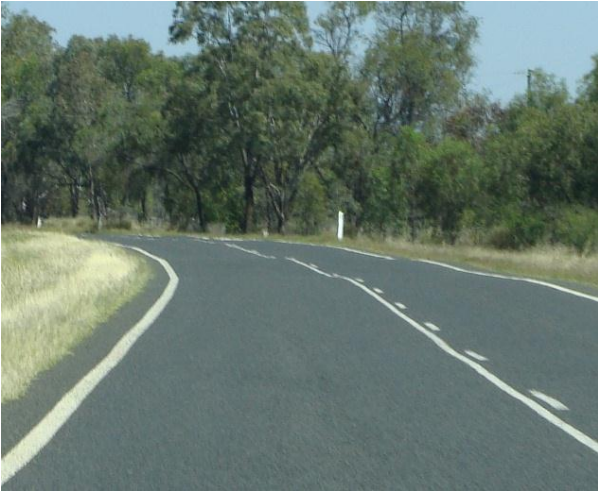
North of Capella the road appears wider and in better condition than the previous survey in 2010, only let down by a slight narrowing approximately 10km south of Clermont and a bumpy ride.

Roadsides are generally clear of hazards and some ATLM is present on edge lines, but not over the entire link.

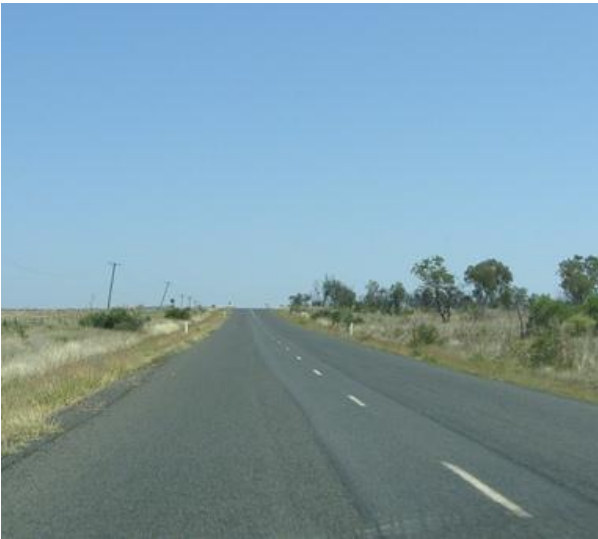
Some shoulder repair / widening works have taken place.

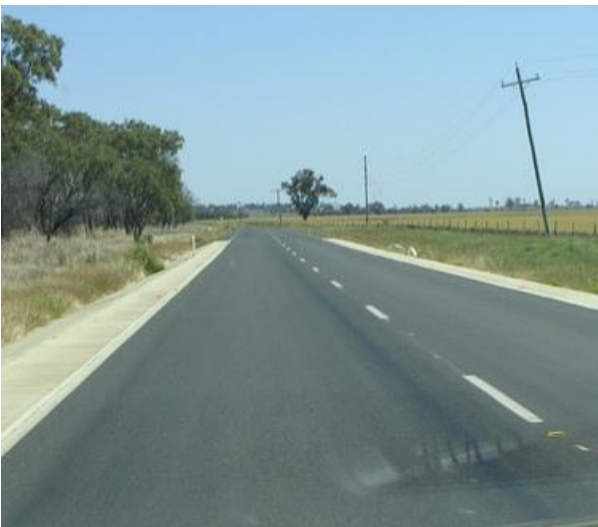
Some floodways have been improved.

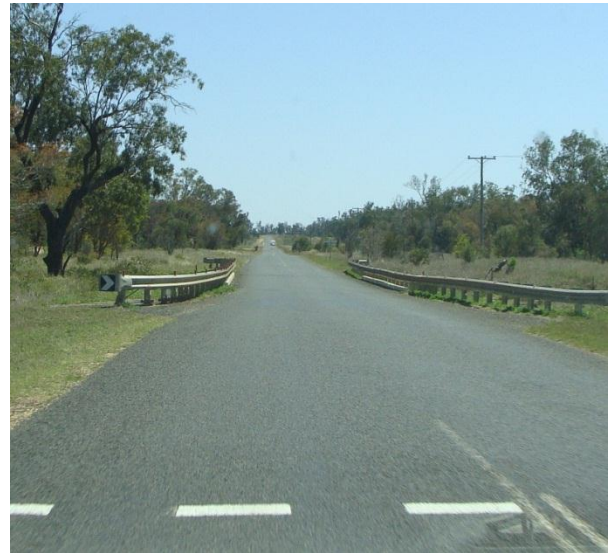
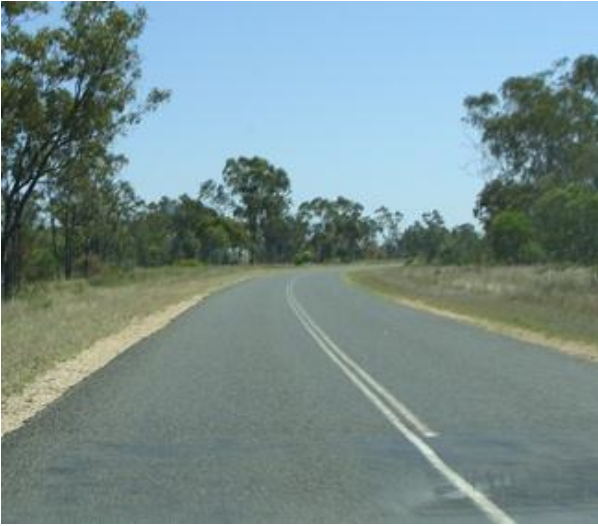
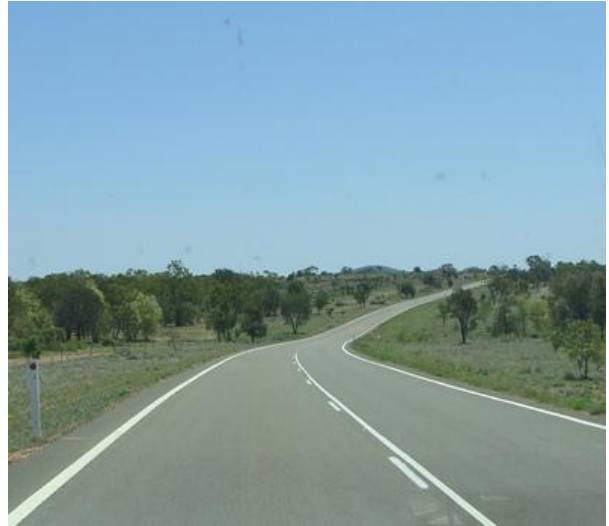
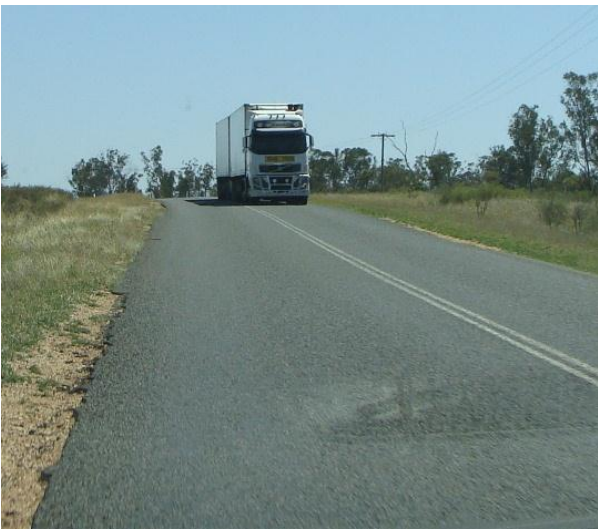
- 25km north of Clermont (7m width for ~10km including a single lane bridge);
- 45km north of Clermont (6.5m-7m for ~35km); and
- 125km north of Clermont (40km to Belyando Crossing), (7m for ~8km)

Roadsides are generally clear of hazards, or a clear zone to trees has been established. However ATLM would be beneficial on edge and centre lines, especially at curves, crests, and bridge approaches.

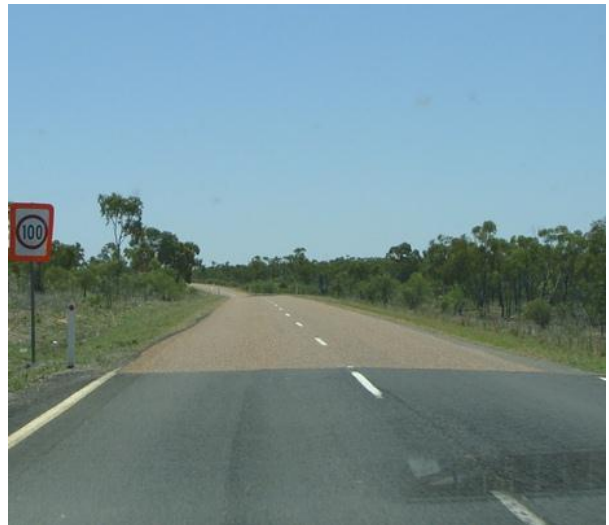
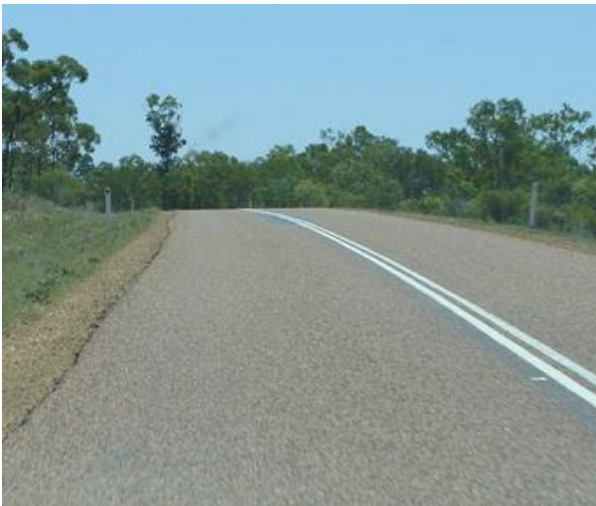
The road width is 8m or more and the surface is in good condition north of Belyando.

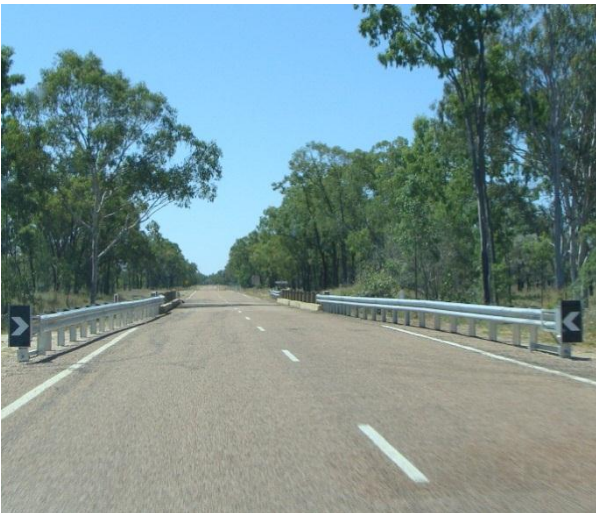
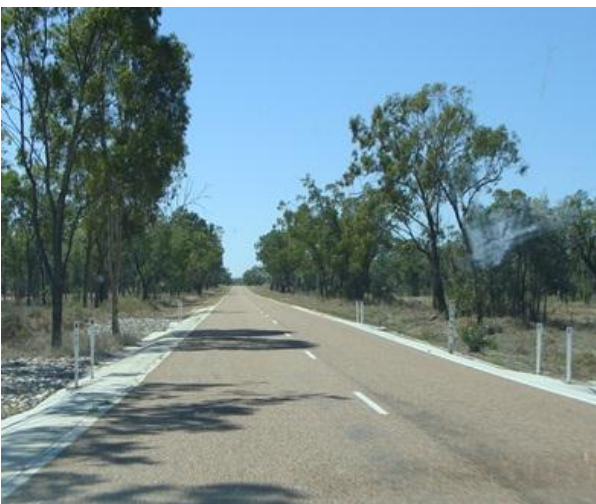
The road width increases to 7.5m – 8m near Cape River and this continues until Charters Towers, apart from narrowing at some creek crossings / floodways, e.g., narrow bridges approximately 55km from Charters Towers.

It appears that some floodways and creek crossings have been improved (e.g., rehabilitated, widened, safety barriers) since the previous survey in 2010.

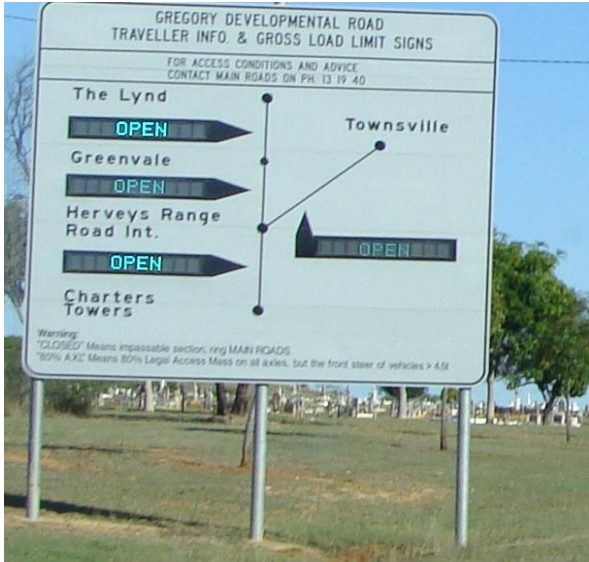
Leaving Charters Towers in the northbound direction a traveller information and gross load limit sign is present to warn of any current road closures or imposed axle weight limits which apply.

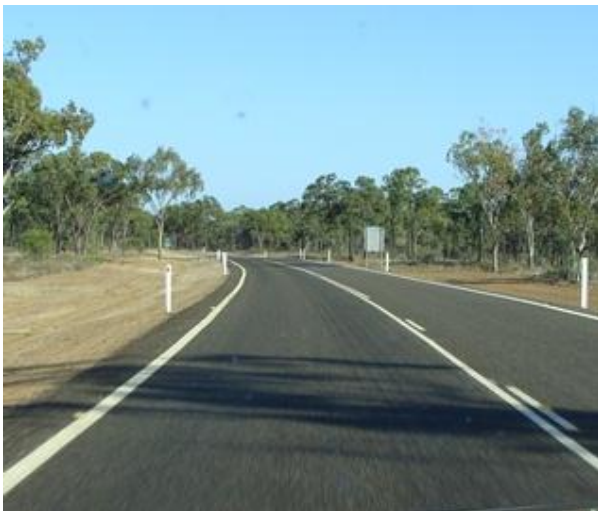
A significant investment has been made under the Gregory Developmental Road Restoration Program to upgrade the road north of Charters Towers.

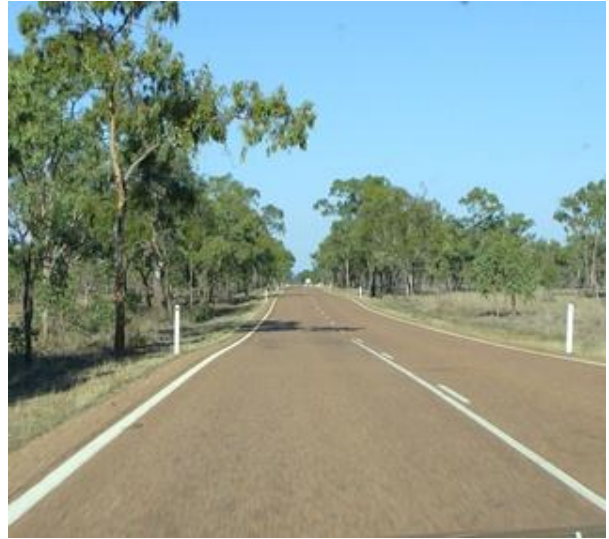
The road is in generally good condition on a straight and flat alignment with good overtaking opportunities for the initial 70km north of Charters Towers.

There are tree-lined sections with some trees within the clear zone. ATLM would be beneficial.

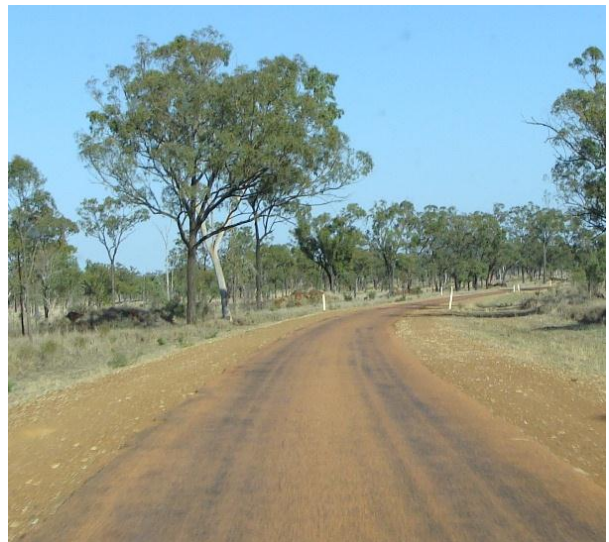
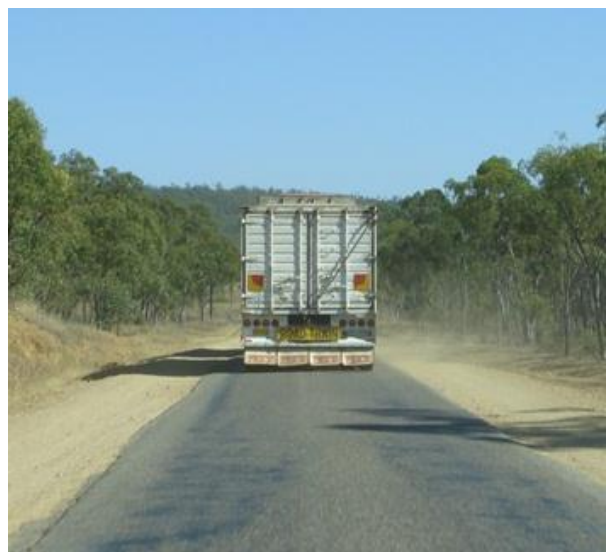
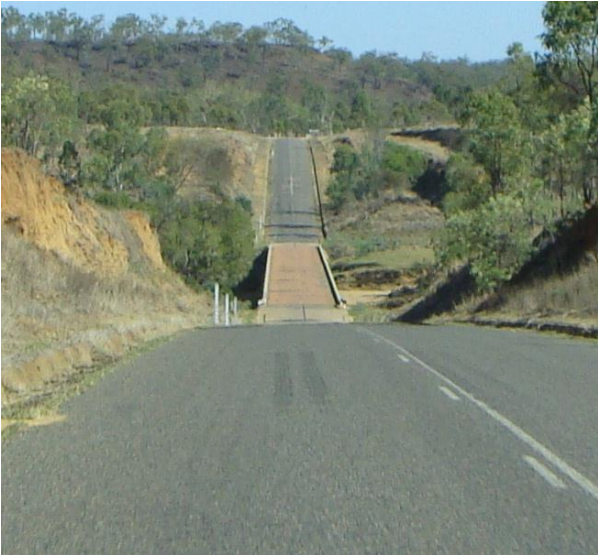
The seal width is generally 8m with wide drainage channels at the side of the road. However there are still a number of narrow bridges and narrow (single lane seal) sections between Charters Towers and Greenvale.

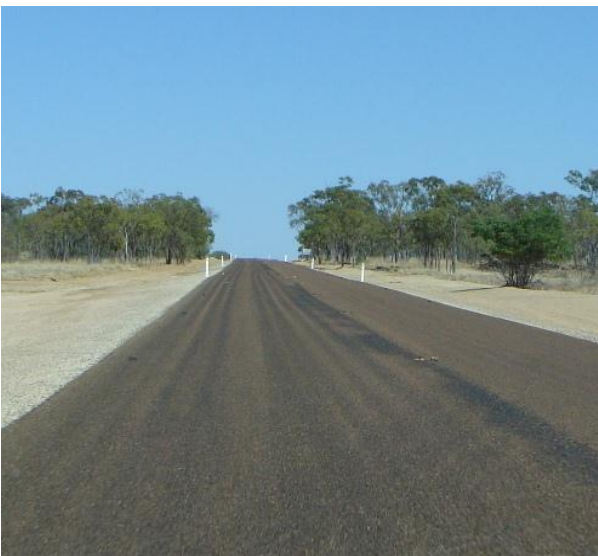
From Greenvale to The Lynd (50km) the road width is 7.5m – 8m and is in generally good condition (apart from a short section around Greenvale, including a narrow crossing). Some new seals have recently been laid.

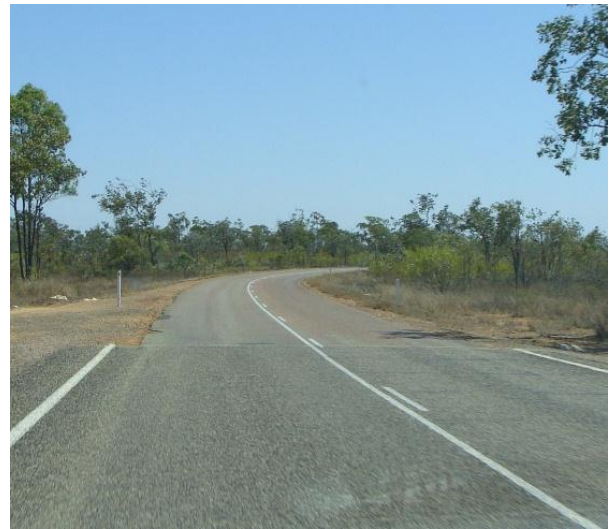
The seal width is generally 8m apart from a number of short, narrow width sections (5m – 6m) for 20km north of The Lynd turnoff.

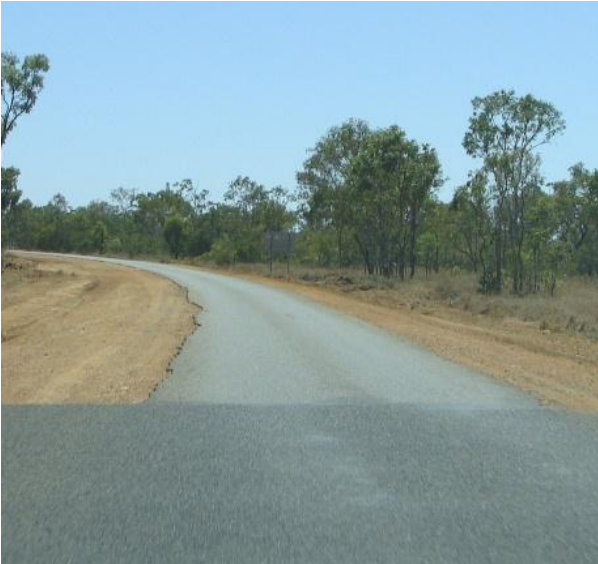
The most notable narrow section occurs approximately 35km north of The Lynd turnoff and is 8km in length.

The narrow sections have issues such as deep drop offs and an unstable shoulder meaning that passing vehicles (especially road trains) must be taken with caution.

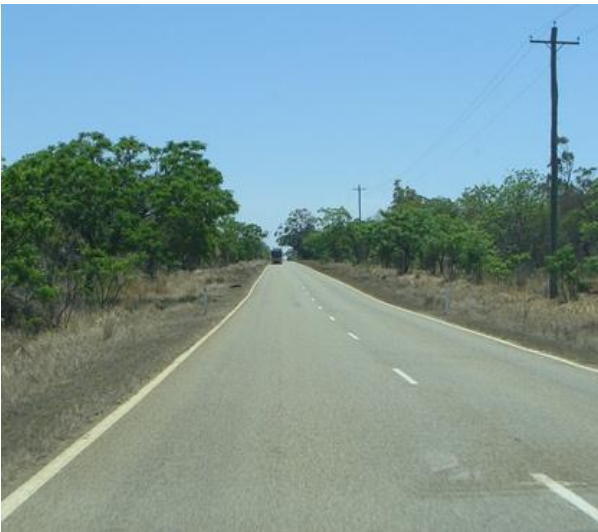
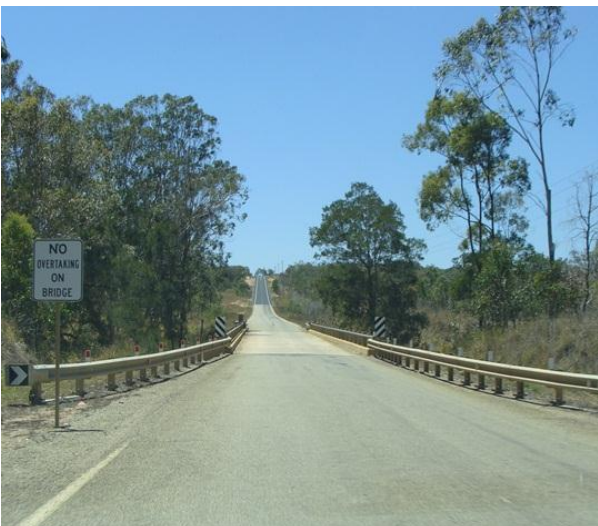
The Kennedy Highway begins at Gulf Developmental Road and the road continues as 8m but with some 7-8m sections. There are also a few narrow bridges, e.g., 15km and 35km north of Gulf Dev. Road, and just south of Mt Garnet.

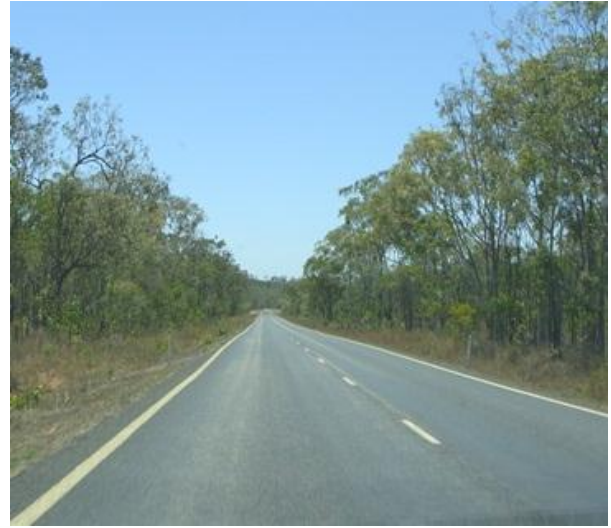
Trees are generally outside the clear zone but ATLM would be beneficial along this section, including some tree removal where they encroach on the clear zone.

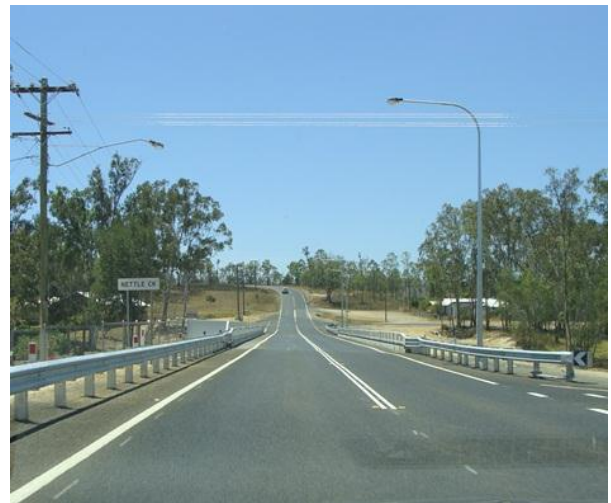
The road continues as 7.5m – 8m up to Innot Hot Springs where the Nettle Creek bridge upgrade has been completed.

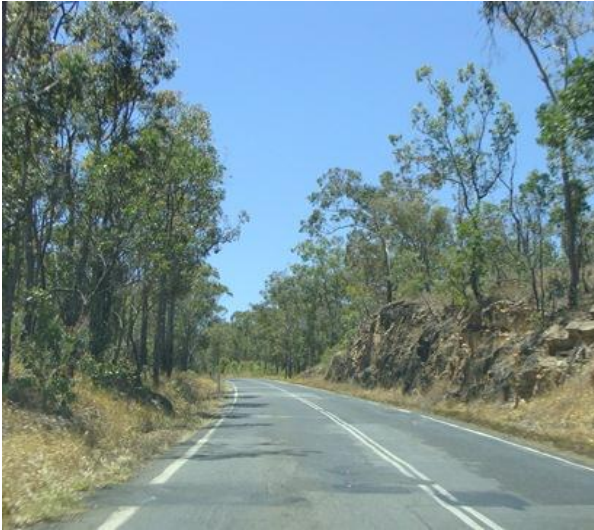
The road width varies between Innot Hot Springs and Ravenshoe. Some lengths require shoulder widening to meet a minimum 8m standard, although due to the terrain (cuttings and rocky outcrops) it would be more expensive to widen.

Narrow sections are susceptible to surface failures and have significant roadside hazards such as trees, and rocks. ATLM on edge and centre lines should be installed.

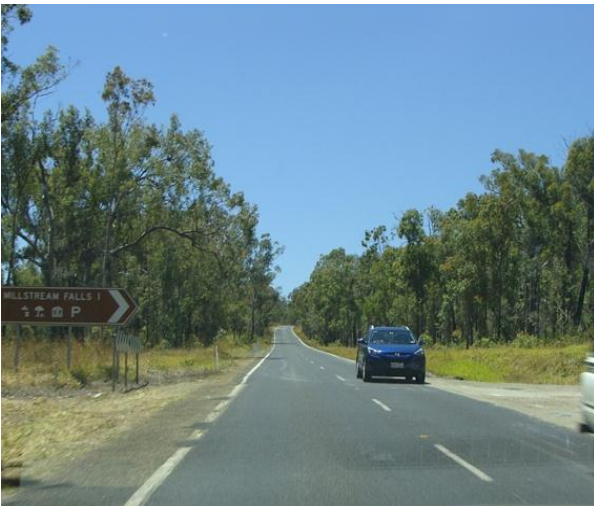
The intersection to Millstream Falls (a tourist attraction) currently lacks safe intersection features such as a protected right turn lane and left (auxiliary) deceleration lane.

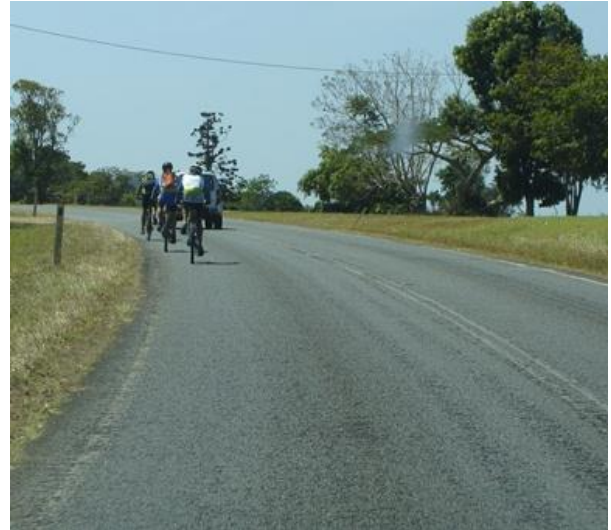
The road width varies but can be <7m in sections to Mareeba, traversing rainforest areas.

Pavement markings require remarking 5-15 km south of Atherton.

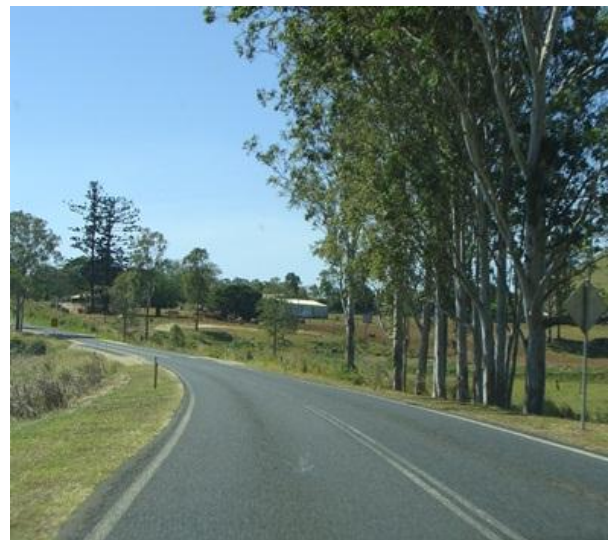
Traffic volumes (especially heavy vehicles) ramp up, and with limited overtaking lanes and opportunities, waiting to pass a slow vehicle can be frustrating.

Roadside hazards continue to be a concern.

An overtaking lane (in each direction) between Tolga and Walkamin would reduce driver frustration and potentially unsafe overtaking manoeuvres.

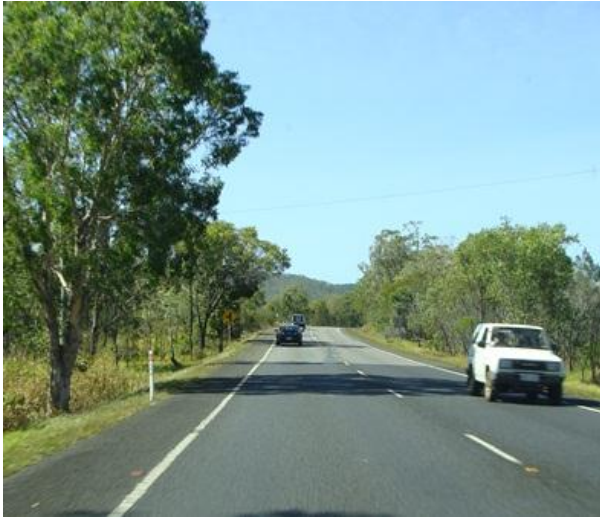
There are sections with roadside hazards such as trees and poles close to the carriageway.

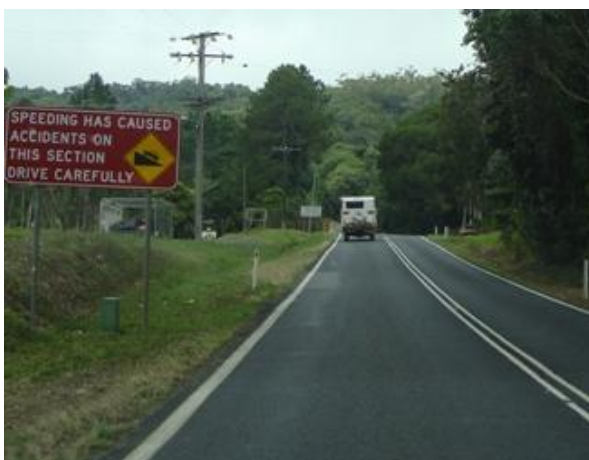
ATLM is used on the edge line and the road surface is in good condition, however this could be extended, especially on curves and crests or where roadside hazards are unable to be removed or protected.

There are very limited overtaking opportunities and encountering slow moving vehicles such as trucks and caravans is common.

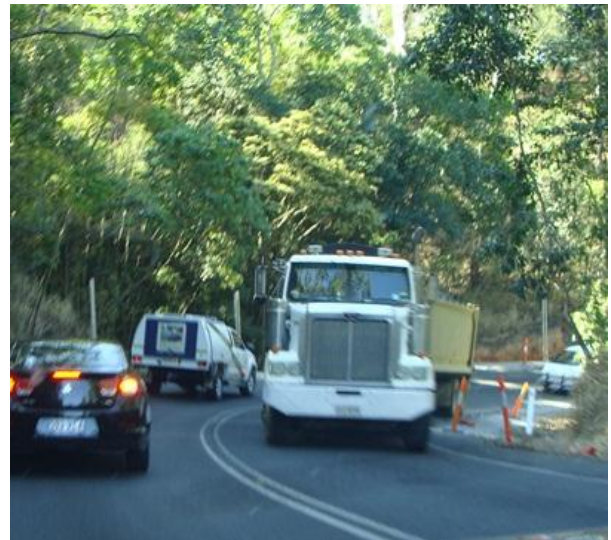
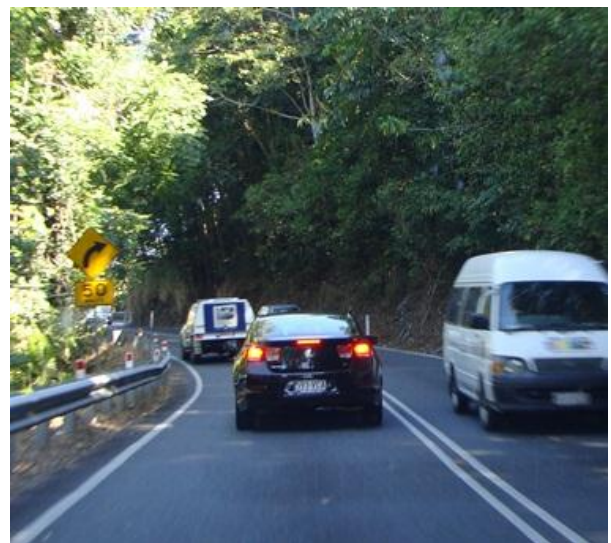
There continue to be works to widen corners and stabilise the roadside along the Kuranda Range.

There is considerable use of safety barriers along the range section, however not all hazardous roadsides or embankments are protected.

**Kuranda Range upgrades should focus on widening curves, additional safety barrier treatments and intelligent signs that warn of excess speed / substandard curves, adverse weather or slippery surface conditions.**
